Test and Analysis of a Stitched RFI Graphite-Epoxy Panel with a Fuel Access Door

March 1994

TEST AND ANALYSIS OF A STITCHED RFI GRAPHITE-EPOXY PANEL

WITH A FUEL ACCESS DOOR

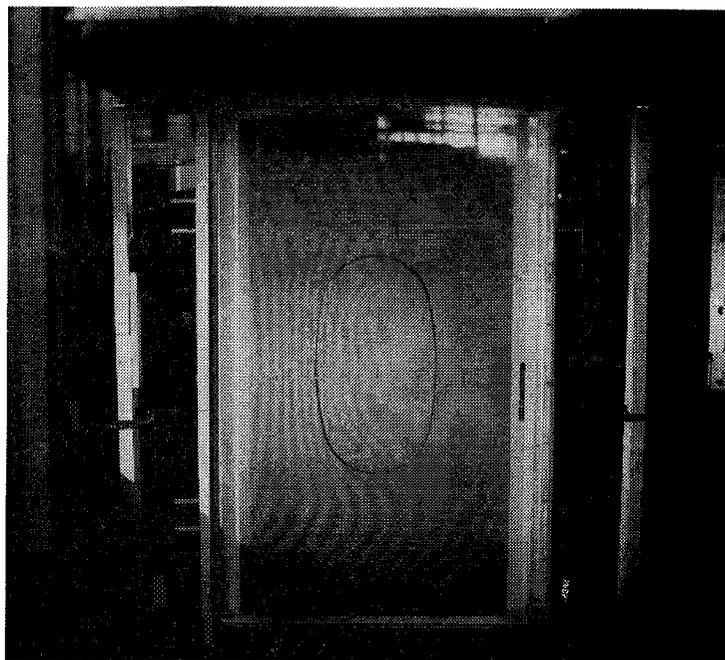
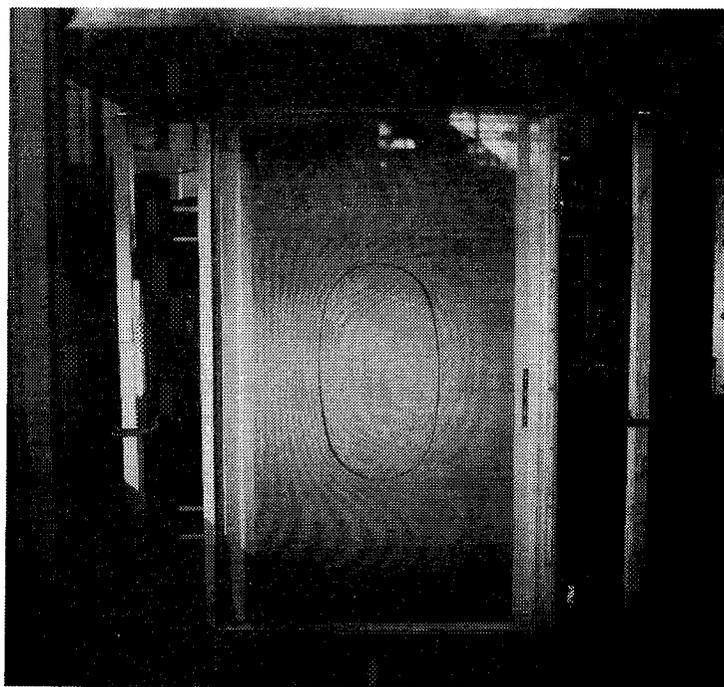
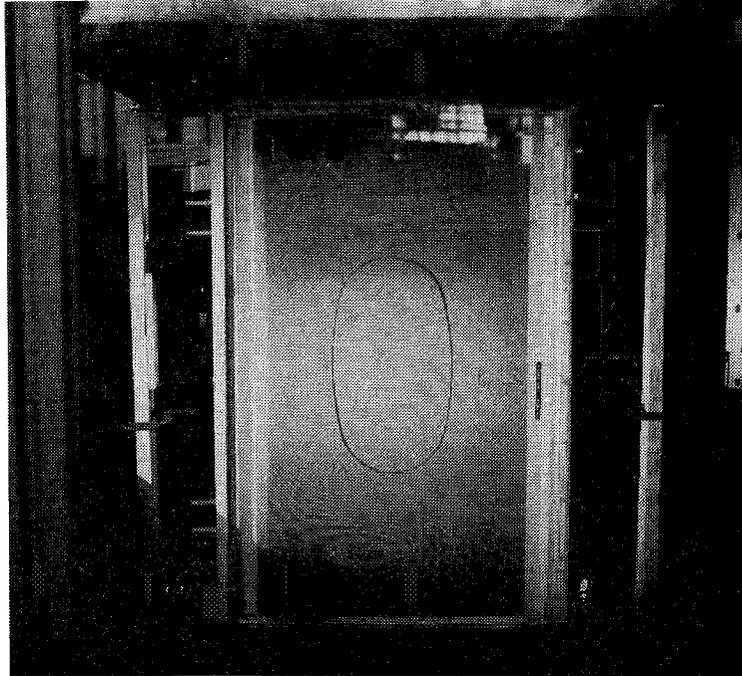
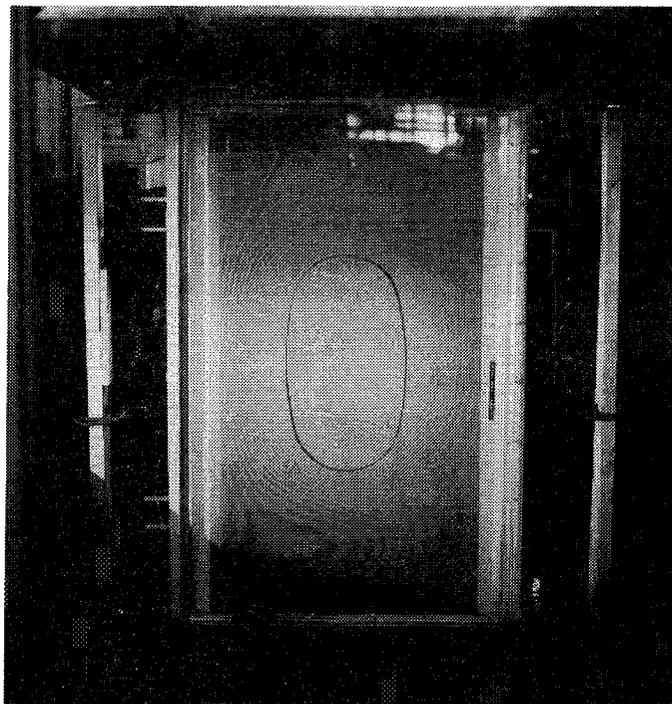
Figure 8. Out-of-plane deformation patterns of panel during loading.

shown in figure 8 for load levels, P , of 210,000 lb ($P/P_{\max} = .30$), 396,000 lb ($P/P_{\max} = .57$), 591,000 lb ($P/P_{\max} = .85$) and 671,000 lb ($P/P_{\max} = .97$). These moire patterns show the overall progression of the out-of-plane deformation during loading.

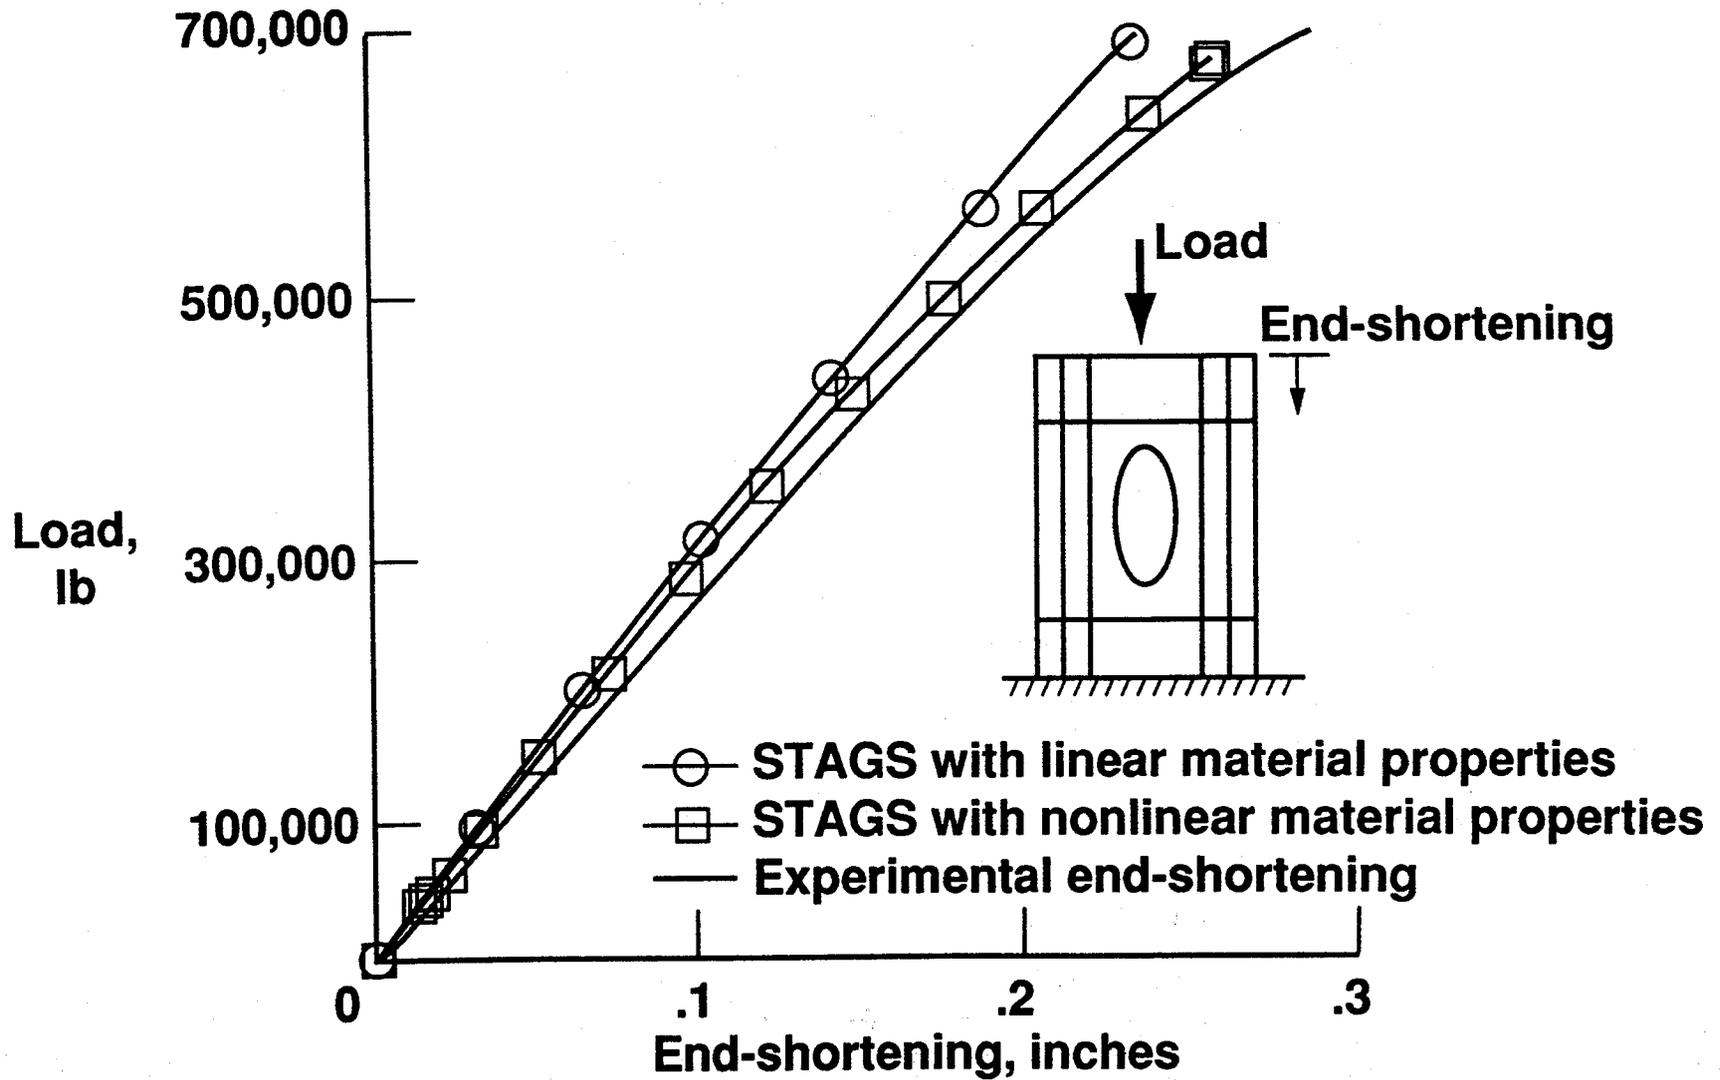
Figure 10. Experimental and analytical end-shortening.

Measured end-shortening of the panel during loading at approximately the lateral centerline of the panel indicates that there was no significant change in global stiffness prior to a load of approximately 85 percent of the failure load. In the load range within 10 percent of the failure load, the global stiffness is reduced by 40 percent compared to the initial global stiffness. This result and the end-shortening predicted by finite element analysis using linear and nonlinear material properties are shown in figure 10. The analysis using linear material properties results in an initial global stiffness 11 percent higher than the measured stiffness of the panel, while the analysis using nonlinear properties results in an initial global stiffness .7 percent higher than the measured stiffness of the panel.

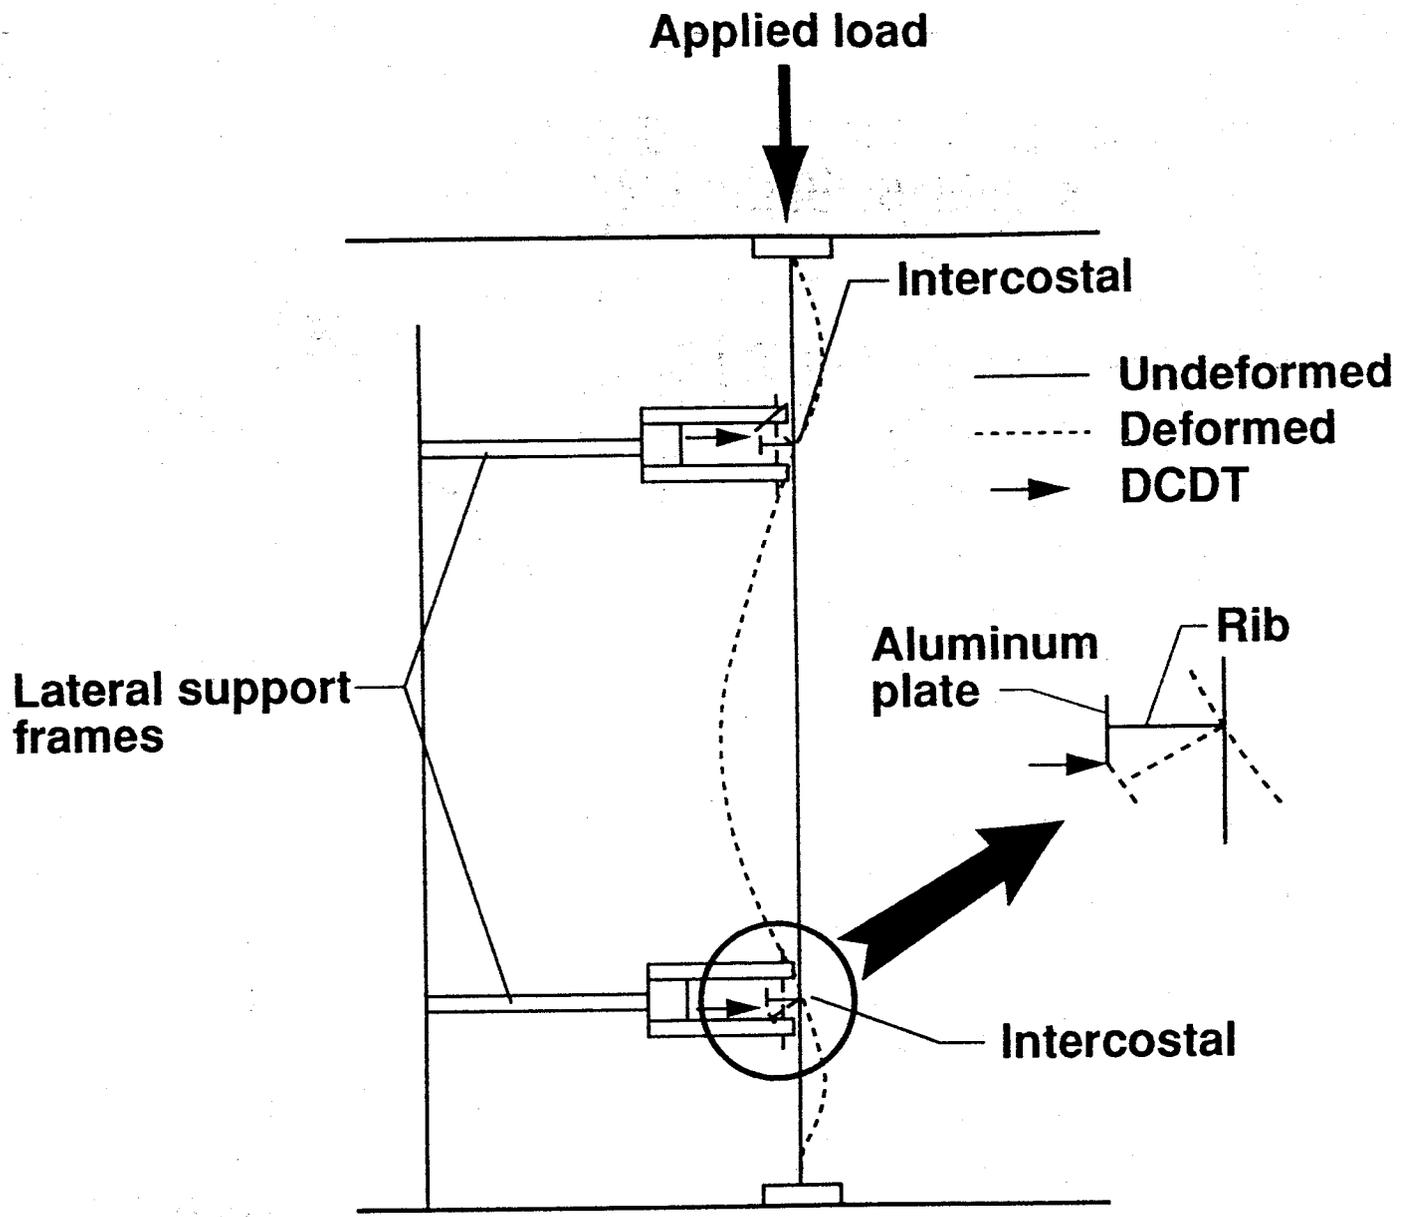
Figure 11. Sketch of side view of panel out-of-plane deformations showing rib rotation.

A sketch of the deformations showing the end-shortening and out-of-plane deformations is shown in figure 11. The locations of the lateral support frame and the intercostals of the panel are shown. Prior to loading, an aluminum plate approximately one inch square was bonded to the top of the rib of each intercostal perpendicular to the rib and near the lateral center, so out-of-plane deformation measurements could be taken. As the panel shortens, the loaded ends and the intercostals do not move out-of-plane. All other parts of the panel except the potted ends do move out-of-plane. The intercostals move downward as the panel shortens. As the skin and stringers deform out-of-plane, the intercostal ribs are forced to rotate, as shown in the figure. The motion of the intercostal ribs was monitored by one DCDT on the top intercostal and another DCDT on the bottom intercostal measuring the out-of-plane motion of the aluminum plate bonded to the end of the intercostal rib. As the rib rotates, the aluminum plate also rotates. The measurement location remains unchanged relative the test machine, but since the panel shortens, the measurement locations change relative to the intercostal ribs. Therefore, this measurement is an accurate measure of the out-of-plane deformation until rib (and plate) rotation begins. DCDT measurements at the intercostal ribs are shown in figure 12. These results indicate that the ribs begin to rotate at a load of approximately 400,000 lb. Prior to that load level, the results indicate that no out-of-plane intercostal rib deformation takes place. Since the end-shortening and intercostal deformation plots are smooth curves and no damage to the connection pins through the intercostal ribs was visible after the test, the assumption is made that no binding occurred as the ribs rotated.

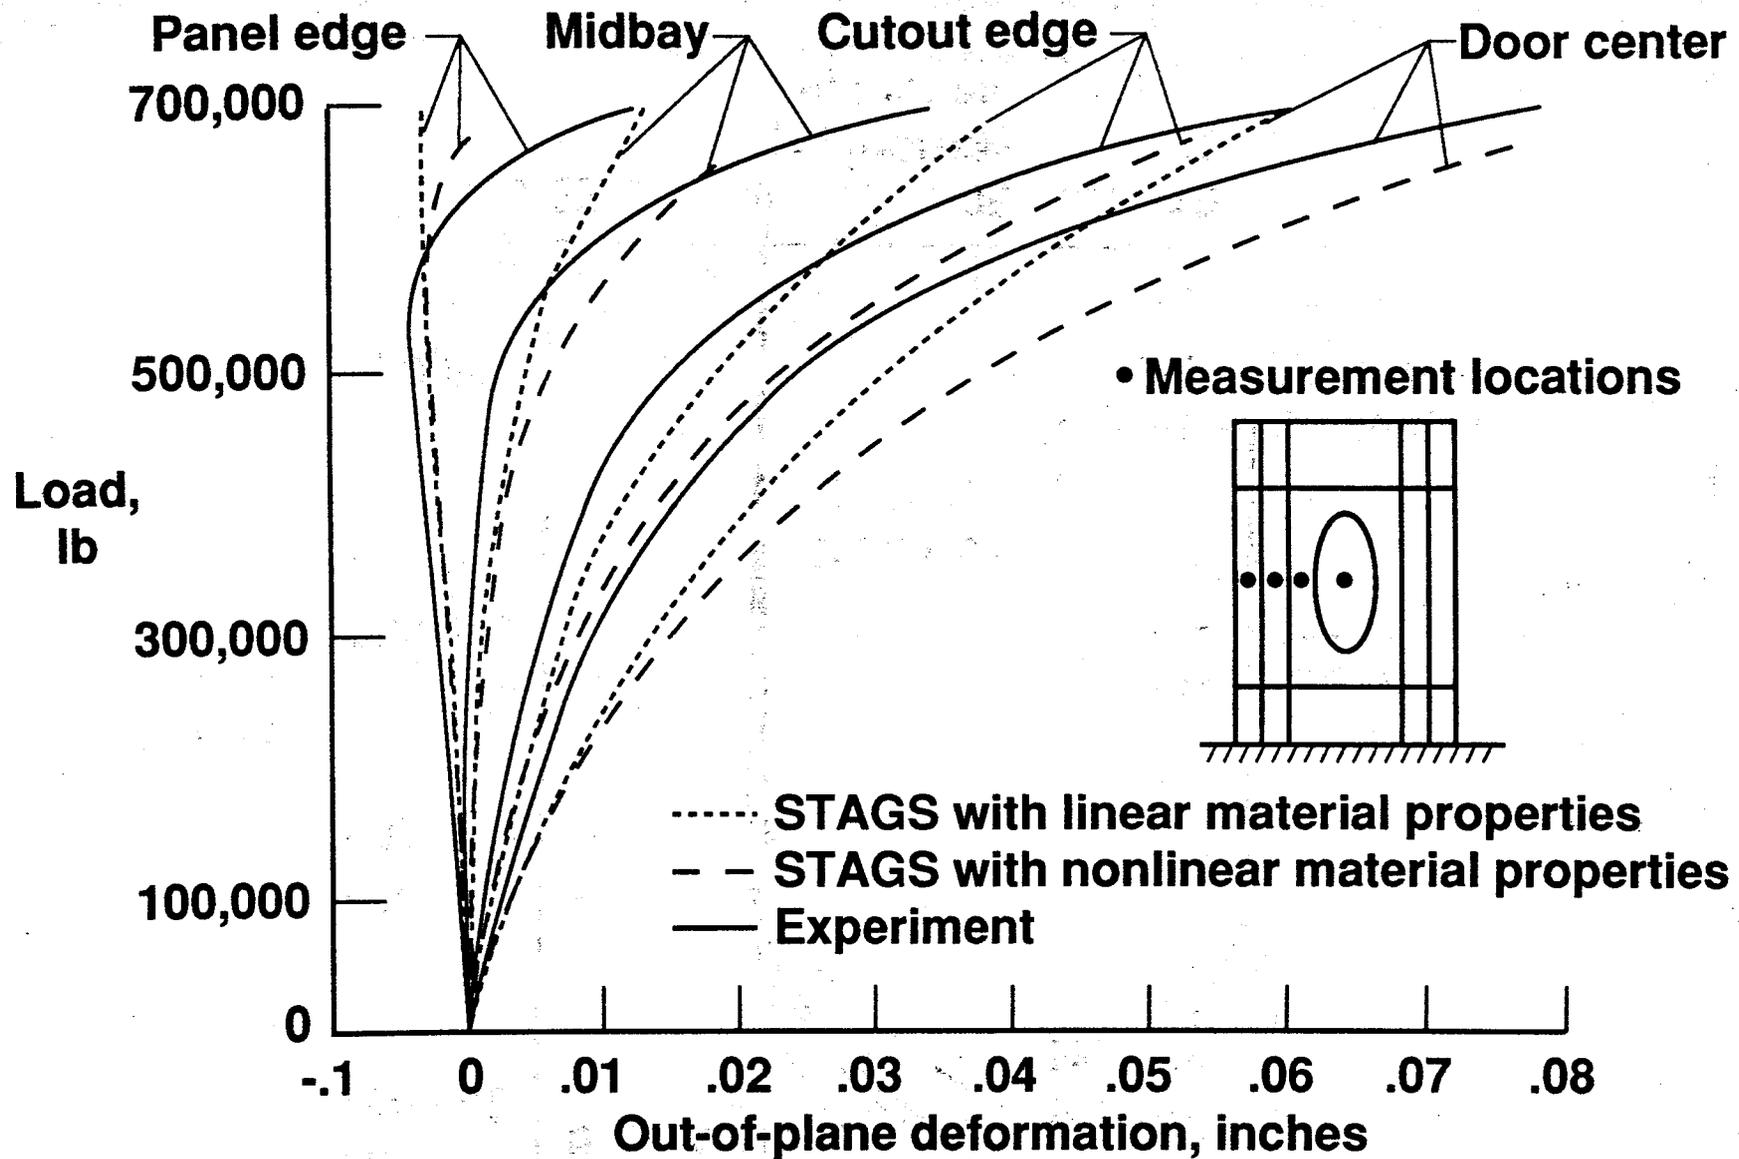
Figure 13. Experimental and analytical out-of-plane motion at panel centerline.

Four DCDT's measured out-of-plane motion along the axial centerline of the panel, as shown in figure 5(b). These measurements are shown in figure 13 and indicate that out-of-plane deformations take place at very low load levels. At failure, the center of the access door has moved out-of-plane almost .8 inches. The skin next to the access door has moved approximately .6 inches. The maximum deformation at midbay between the stringers is only .3 inches and the panel edge has moved .15 inches. The deformations at these locations predicted by finite element analysis are also shown in figure 13. The analysis with linear material properties consistently predicts significantly lower deformations than those measured. The analysis with nonlinear material properties predicts deformations with the same trend in deformation as the measurements and predicts more accurate deformations at failure than the analysis with linear material properties.

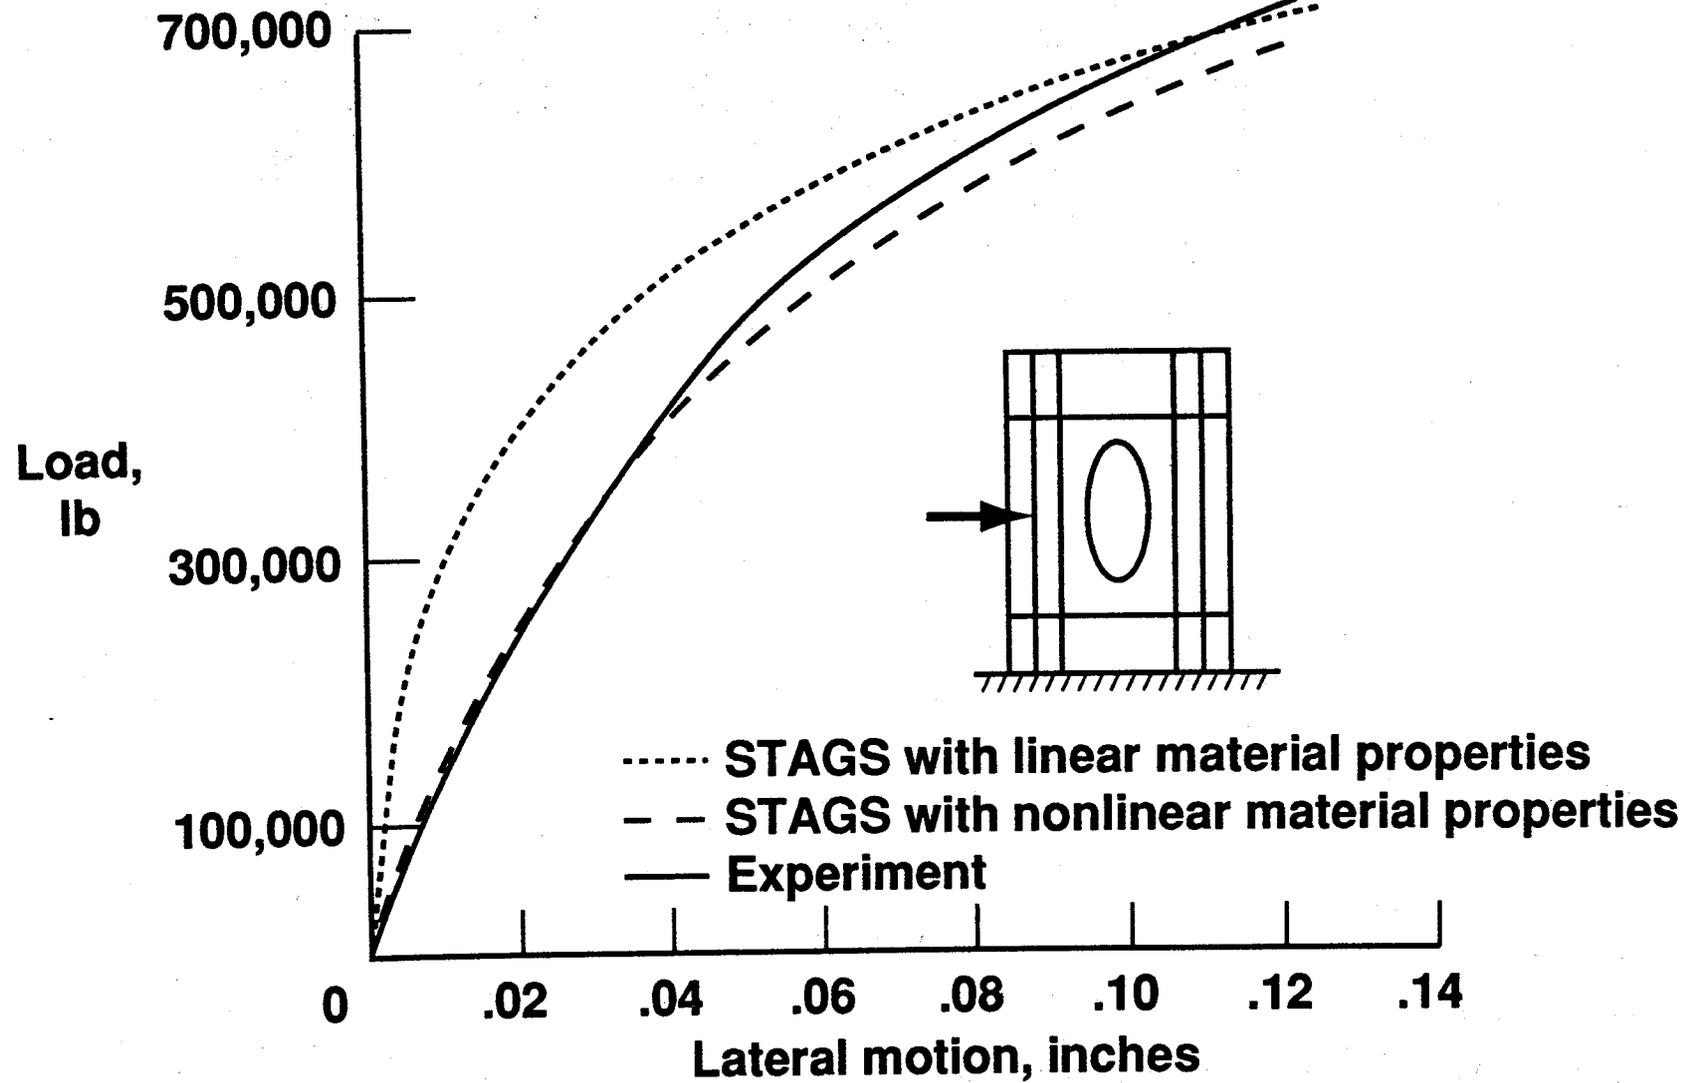
Figure 14. Experimental and analytical rolling of outermost stringer.

A measurement of the motion in the lateral direction of one of the outermost stringers representing the rotation due to rolling of the stringer is shown in figure 14. Calculated motion representing rolling of the stringer is also shown in the figure. This measurement indicates that rolling occurred from the onset of loading. Analysis using linear material properties shows the correct trend but not the correct displacement values. Analysis using nonlinear material properties accurately predicts this motion.

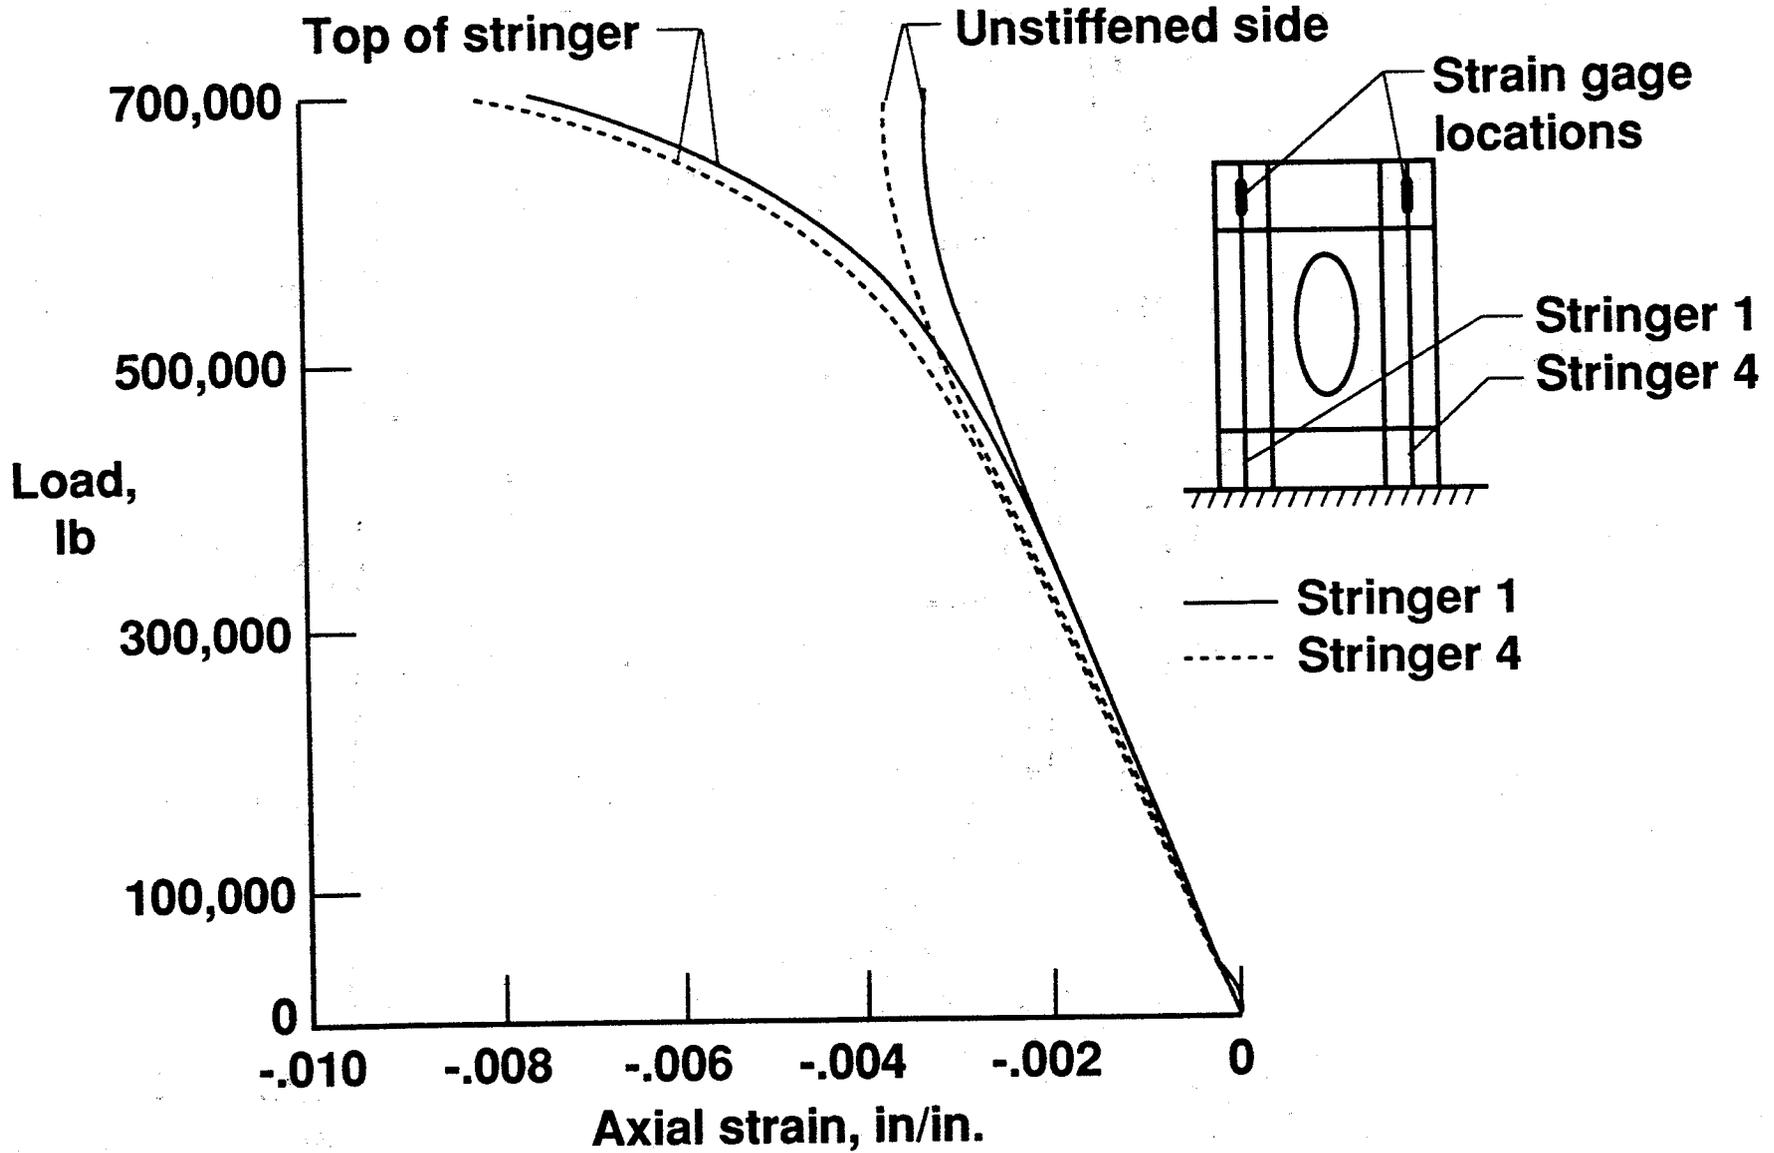
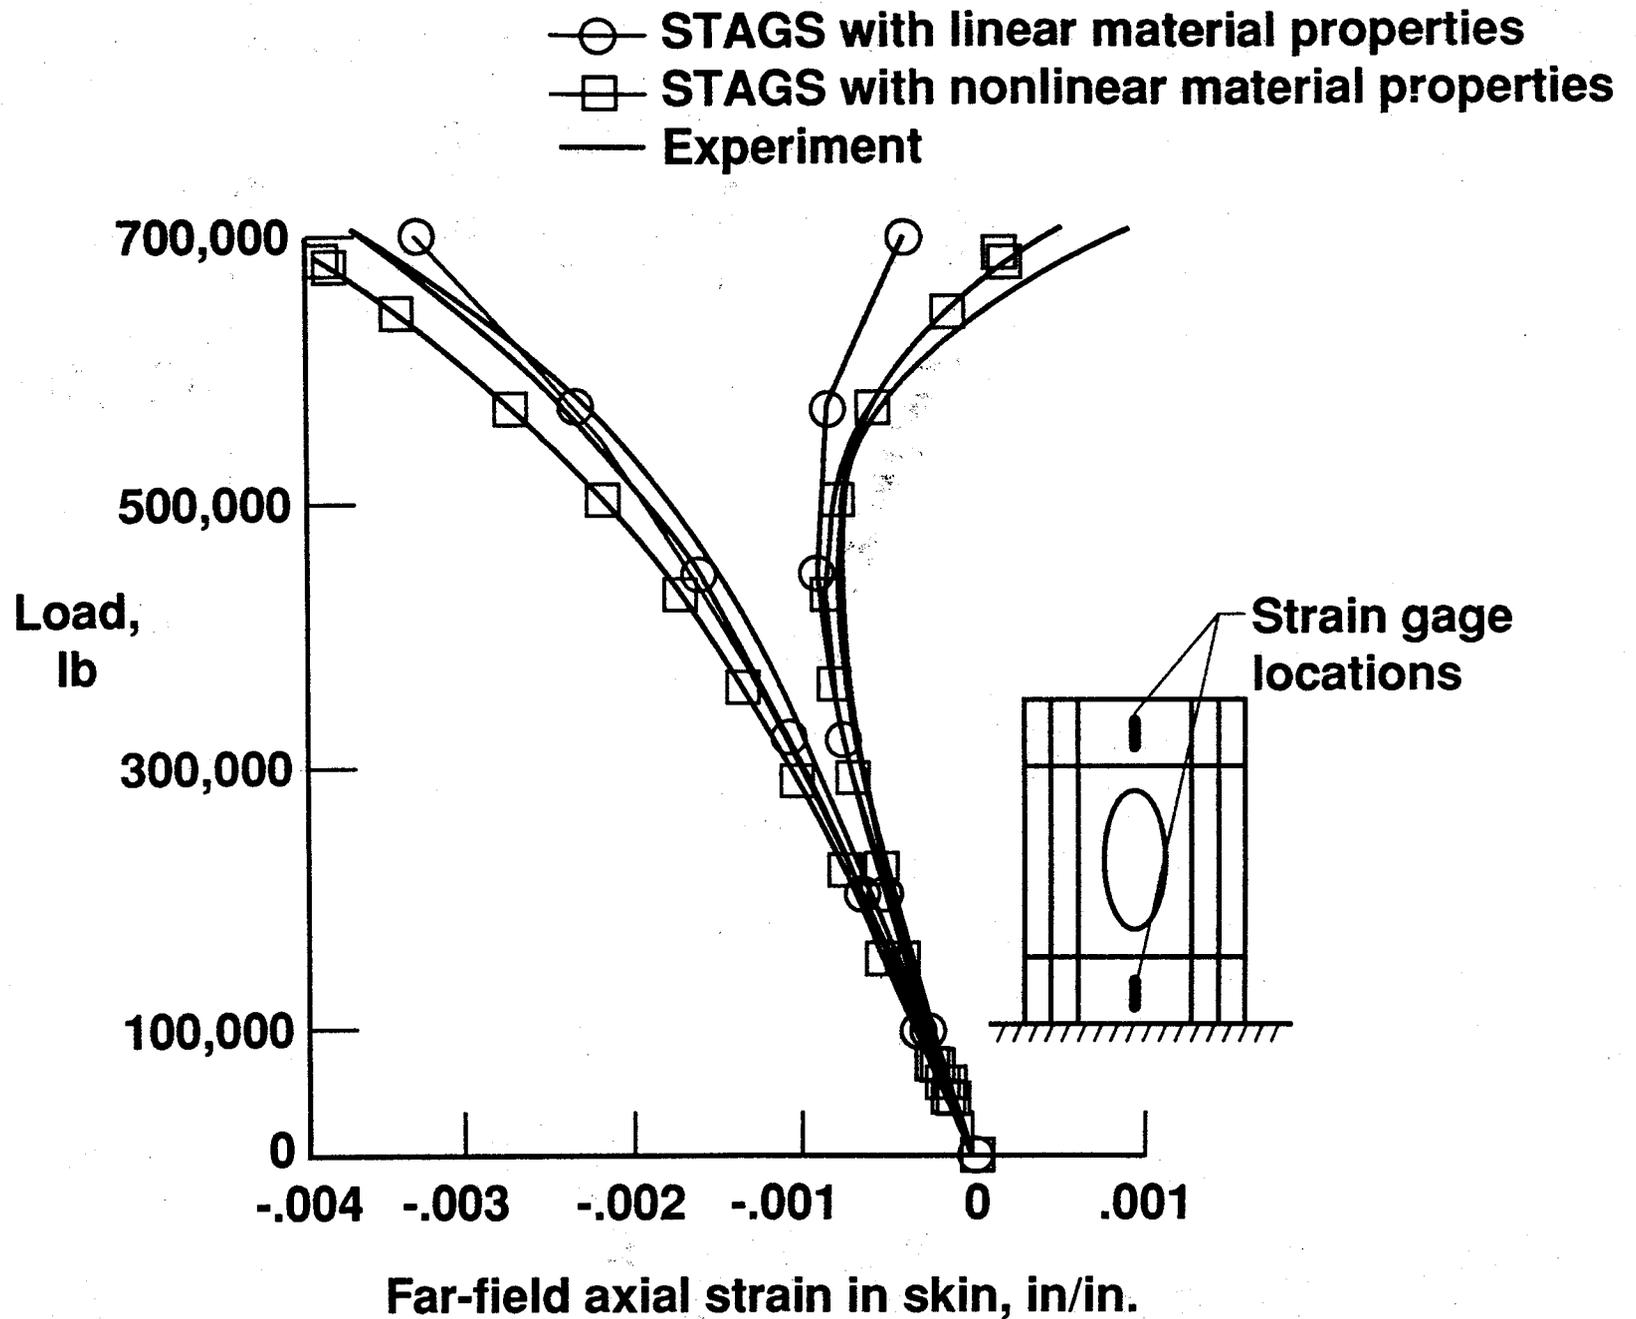
Figure 15. Axial strain away from access door.

Strain gages were located far from the access door to determine whether the load introduction was constant across the width of the panel. Strains recorded by back-to-back strain gages on the top of the outermost stringers and the opposite skin are shown in figure 15(a). These strain gages indicate

uniform load introduction occurred until this region of the panel started to bend at about 400,000 lb. After bending initiated, the back-to-back strain gages on the stringers and the skin no longer recorded the same strain. Strain gages were also placed far from the access door on the lateral centerline to monitor bending in the skin above the top intercostal and below the bottom intercostal. Strains recorded by these strain gages are shown in figure 15(b). Predicted strains at these locations are also shown in the figure. Significant bending takes place in the panel skin for loads above about 200,000 lb. Predicted strains from analysis using nonlinear material properties agree with the test data.
